Industrial Slab-on-Ground Surface Defects

Mortar flaking over aggregates may be related to large top-size aggregates, other issues

by Arthur W. McKinney and Joseph F. Neuber Jr.

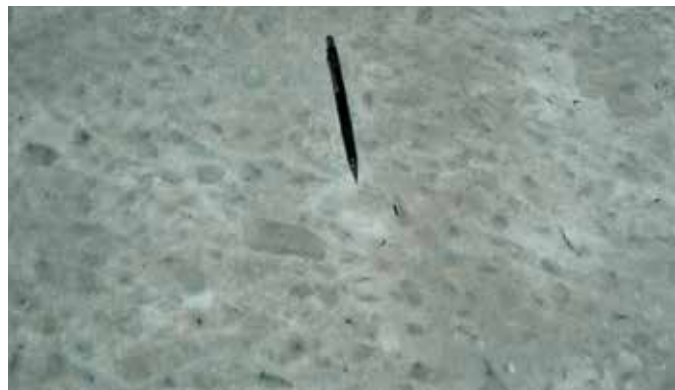
Fig. 1: An example of aggregate shading on the surface of a 10 in. (250 mm) thick floor constructed in 2007. The mixture used on this project comprised large aggregate with very elongated top-size particles, nominally 4 x 1 in. (100 x 25 mm). While the unusual aggregate made it a challenge to achieve adequate embedment, flaking of the surface was observed only in a very limited area

Aggregate shading is a mottling of trowel-finished concrete associated with coarse aggregate particles near the slab surface (Fig. 1). Greening and Landgren¹ noted important factors that could cause darkened zones of concrete. These included:

It's apparent that compression dewatering due to troweling causes a lowered w/c in the mortar above the near-surface aggregate particles, so dark zones result.

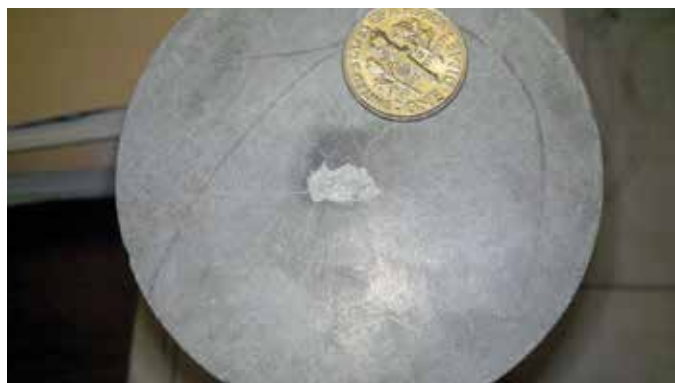
Fig. 2: Close-up of typical flaked area on slab placed in 2012. Note that the nearby surface is darkened and exhibits craze cracking. For scale, a U.S. dime is about 0.71 in. (18 mm) in diameter

While the individual defects are relatively small (Fig. 2) and the adjacent areas are typically sound, we've found that defects can occur in clusters (Fig. 3 and 4). Small bumps may appear on the surface prior to flaking, but that's not always the case. We've also noted that limited craze cracking

may occur around a flake (Fig. 2). Recognition of the problem can be both time- and traffic-dependent.

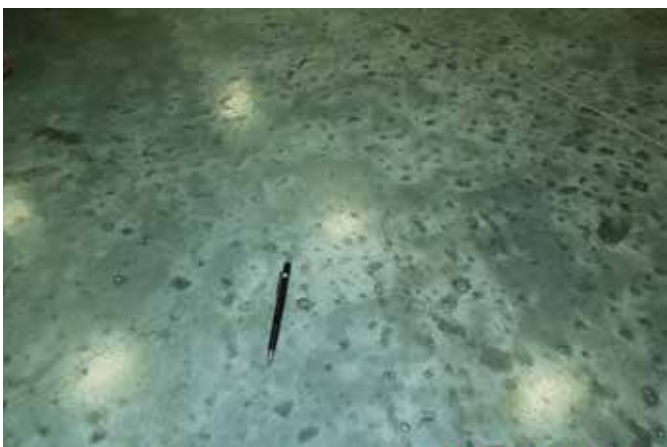
Fig. 4: Surface distress may occur over a wide contiguous area (in this case, the distress covered about 400 ft² (37 m²)). This surface is shown after about 1 year of service, prior to repair

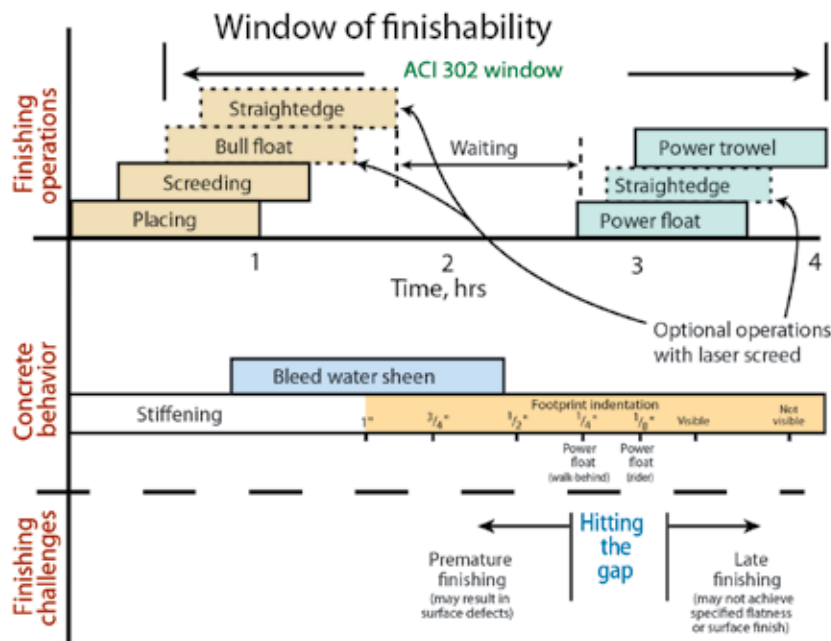
Fig. 6: Finishing operations for a slab-on-ground floor. When a laser screed is used, some traditional operations may not be necessary to achieve a flat and level floor (based on Reference 2) (Note: 1 in. = 25.4 mm)

Figure 6 lists the finishing operations for slab-on-ground floors,² and it illustrates how the timing of the operations should correlate with the behavior of the concrete as it sets and hardens. Placing and finishing floors to high flatness and levelness tolerances, particularly on large projects, has been enabled by the development and use of modern laser-guided screeds (laser screeds) and pan floats.³ While these technologies allow very high productivity (Fig. 7), it’s important that the finishers are aware of potential concerns:

- Finishers may avoid operations that could reduce flatness. While laser screeds can help finishers achieve high flatness numbers without using bull floats or straight edges, skipping these steps may allow large aggregate particles to remain near the slab surface until the power-floating operations begin. A primary purpose for floating is to: “embed the large aggregate beneath the surface mortar layer”⁴ (finishers describe this as “pulling up the mortar” as opposed to pushing down the aggregates). If the finisher waits too long and doesn’t “hit the gap” for using a power float (refer to Fig. 6), it may not be possible to sufficiently embed the large aggregate.

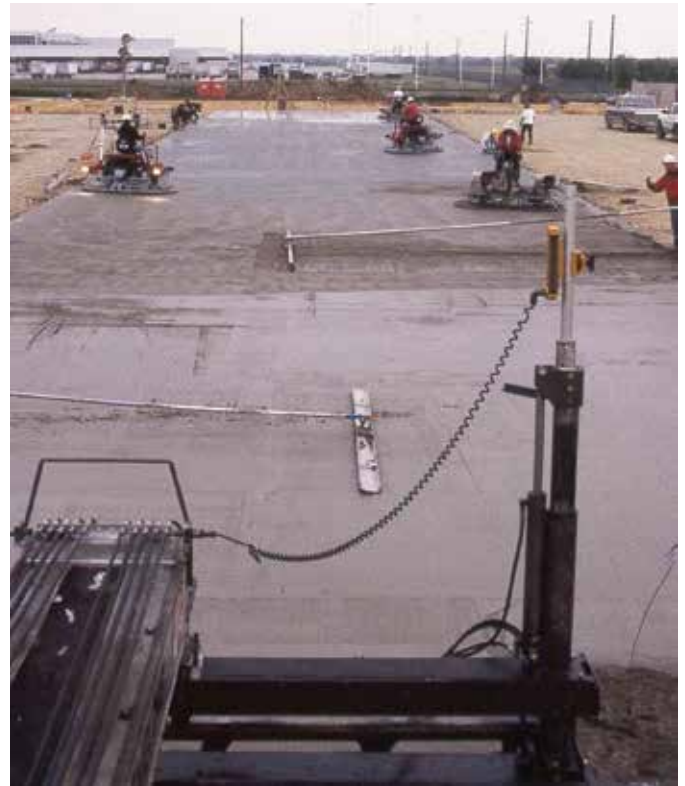
Fig. 7: Typical industrial slab finishing steps: laser screed (fore-ground), bull (channel) floating, check rod, power floating, and power troweling (photo courtesy of Structural Services, Inc.)

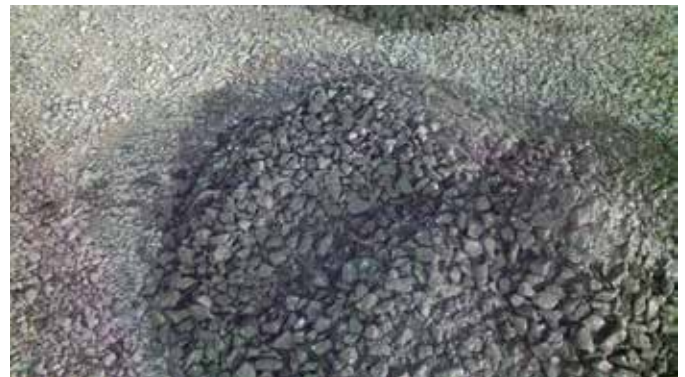
Fig. 8: The first concrete out of the chute is typically segregated toward the top-size aggregate

- The screed bar may be moved too quickly or the vibration level may not be adequate to ensure that large aggregates are moved below the slab surface. This is a particular problem at the end of a pull of the screed bar, before the machine is indexed to its next position. The vibration will be stopped as the screed bar stops moving, and this may leave a windrow of large aggregates near the surface of the placement. The problem can be worsened if the concrete placed adjacent to the windrow is the first material down the chute of a subsequent concrete truck, as the initial discharge is typically segregated toward the top-size aggregate (Fig. 8).

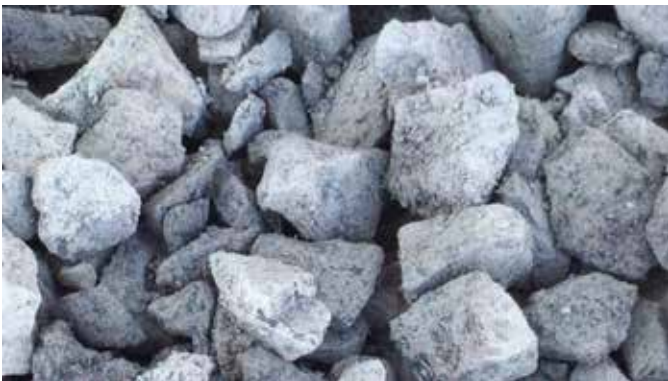
Fig. 9: Coarse aggregate particles coated with fine materials may interfere with bond and thus contribute to flaking

None of these tests, however, deal with the question of "dirty" aggregates (Fig. 9). Analysis of the amount of material passing a No. 200 (75 µm) sieve might serve as an indicator of excessive fines on the coarse aggregate, but ASTM C136 may not accurately determine this quantity. ASTM C117, "Standard Test Method for Materials Finer than 75-µm (No. 200) Sieve in Mineral Aggregates by Washing," should provide a more reliable result.
