Resolving “Sweating” in Open Industrial Concrete Floor Slabs

Problems may be linked to using floors as a casting surface

by Arthur W. McKinney

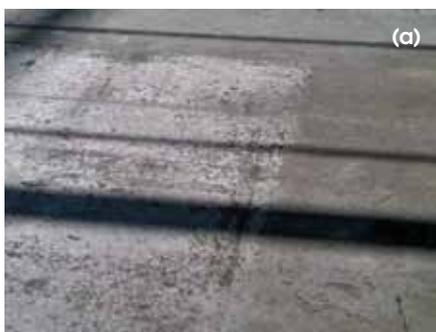
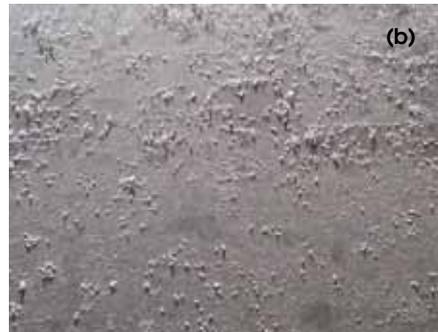
- When drying occurs, white powder, filaments, or crystals may be left on the surface. These have been identified as carbonation products of alkali salts precipitating out of solution. Frequently, such material defines the extent and pattern of tilt-up panels or other components cast on the floor (Fig. 1).

Fig. 1: In many cases, surface moisture problems are associated with the formation of a powder or crystalline residue in areas where tilt-up wall panels were cast: (a) general view of casting area on floor slab; and (b) close-up of crystals

It appears that, unless residual products can be completely removed, their presence and the transport of deliquescent materials to the surface create the persistent wet, slippery surface conditions observed. Adverse chemistry at the floor surface is the root problem.

Where the project reflects the conditions described, deep cleaning of the slab surface to effectively remove residual materials may be the best choice. Recent success with this approach has been encouraging, as it directly addressed the root cause. One issue with such cleaning has been to determine the correct materials and protocols for remediating the problem without damaging the slab surface.

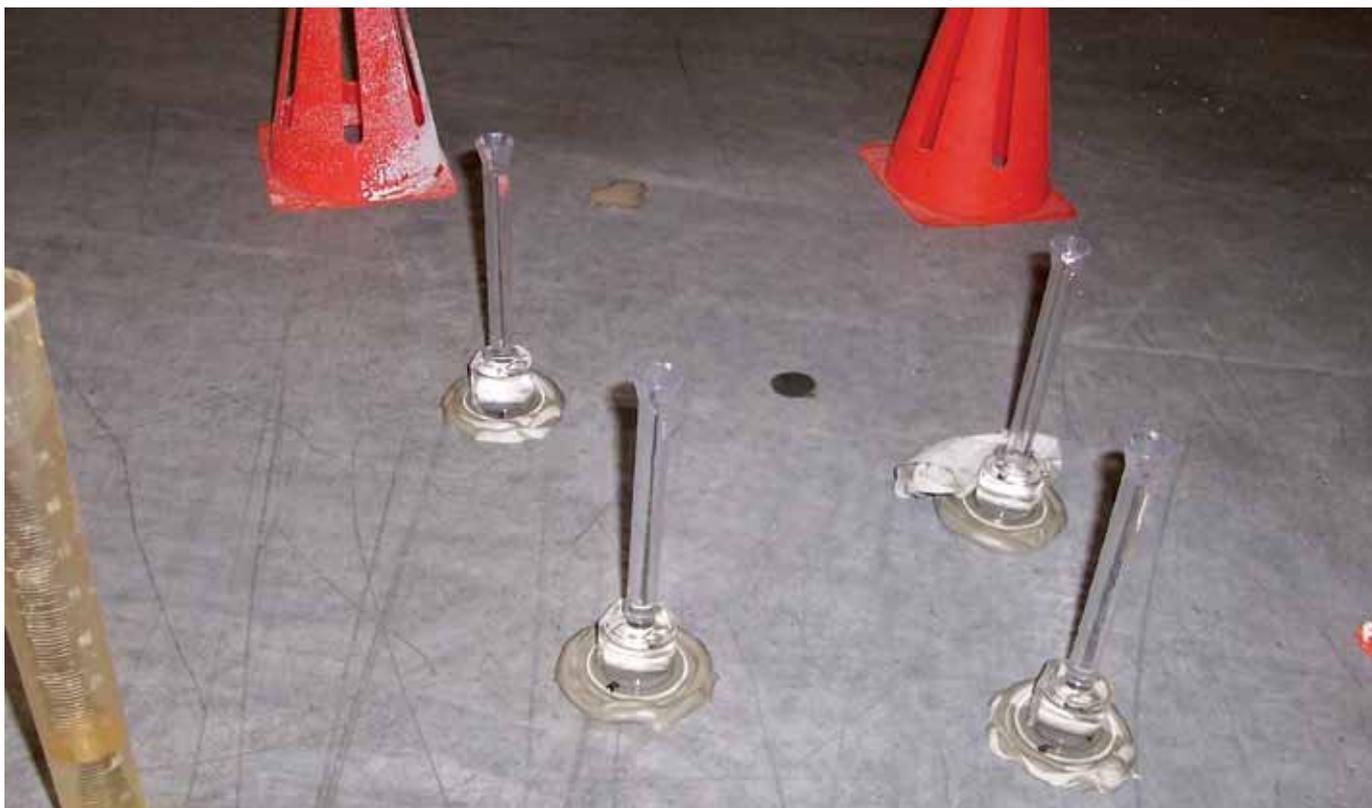
9. After each step, test the floor for water penetration and compare the results with the test area. In recent tests, Rilem tubes have been tried to assess relative improvements in surface absorption. The tubes were sealed to the floor and evaluated over a 2-hour period (Fig. 2). Rilem tubes on concrete can produce erratic results, but multiple tests suggest significant improvement after cleaning.
10. Allow to dry or revacuum.

Fig. 2: Testing for relative absorption using Rilem tubes. In this case, four tubes were used at each test site/cycle
